Manhole Inspection Summary

Manhole # **S15C__011MH**

Insp Date: **10/8/07 10:55 AM**

Location Address: **2540 FRANKLIN ST**

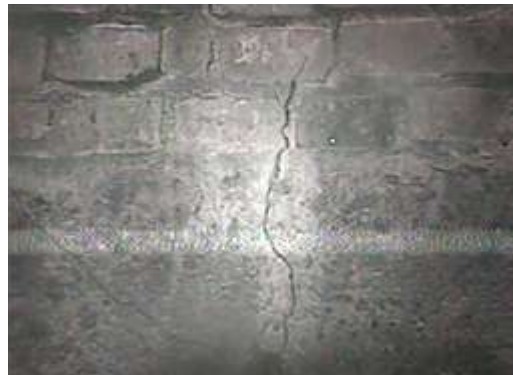
Defect 1

Condition: ☐ Sound ☒ **Cracked** ☐ Root Intrusion ☐ Loose Brick ☐ Deteriorated

CRACKED BARREL

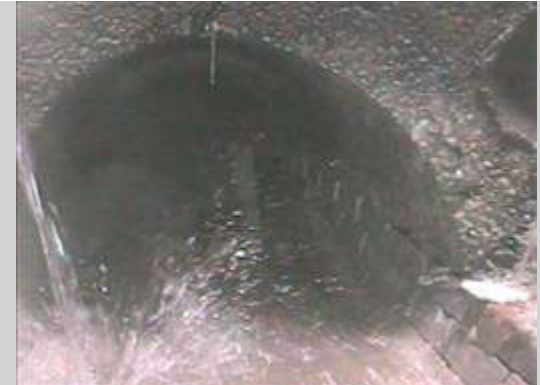
12 O'Clock Outflow

27 in. Circular Gravity Sewer
Pipe Out @ 12 O'Clock

Pipe Height: **25.2** (in.) Rod and Bar
Pipe Material: **Concrete** ☐ Pipe Lined
Invert Depth: **12.90** (ft.) Flow Characteristics: **Fast**
Deposits: ☒ None ☐ Mud ☐ Sludge ☐ Debris ☐ Grease
Silt Depth: (in.) Deposits Extent:
Infiltration: **None** Pipe Seal Cond: **Cracked**

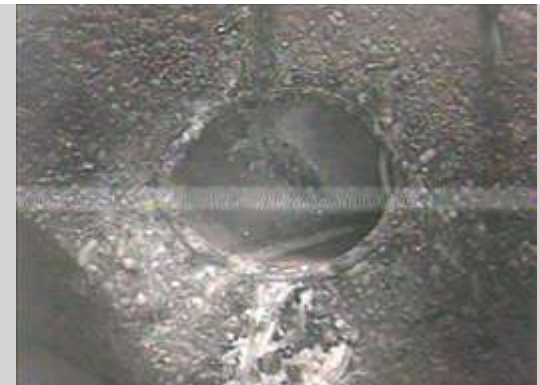
3 O'Clock Inflow

10 in. Circular Gravity Sewer
Pipe In @ 3 O'Clock

Pipe Height: **7.2** (in.) Rod and Bar
Pipe Material: **Clay** ☐ Pipe Lined
Invert Depth: **11.30** (ft.) Flow Characteristics: **Slow**
Deposits: ☒ None ☐ Mud ☐ Sludge ☐ Debris ☐ Grease
Silt Depth: (in.) Deposits Extent:
Infiltration: **None** Pipe Seal Cond: **Sound**

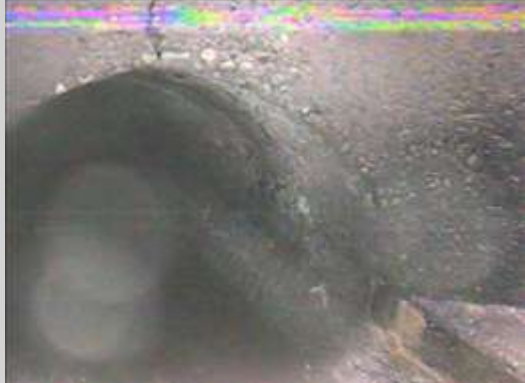
6 O'Clock Inflow

27 in. Circular Gravity Sewer

Pipe In @ 6 O'Clock

Pipe Height: **22.8** (in.) Rod and Bar

Infiltration: **None** Pipe Seal Cond: **Cracked**

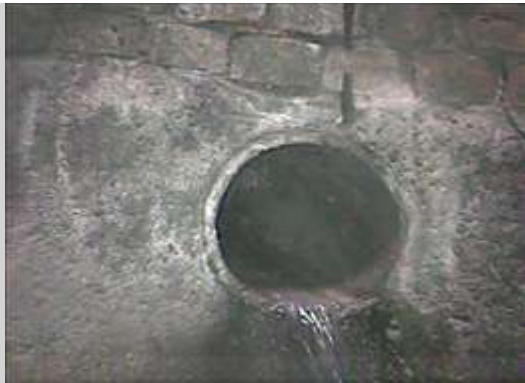
9 O'Clock Inflow

8 in. Circular Gravity Sewer

Pipe In @ 9 O'Clock

Pipe Height: **7.2** (in.) Rod and Bar

Infiltration: **None** Pipe Seal Cond: **Sound**
